The GRIME

February / March 2011
Newsletter

Keep The Basics Of Water And Steam Physics In Mind

Reactivating Idle Boilers Requires Proper Safety Procedures

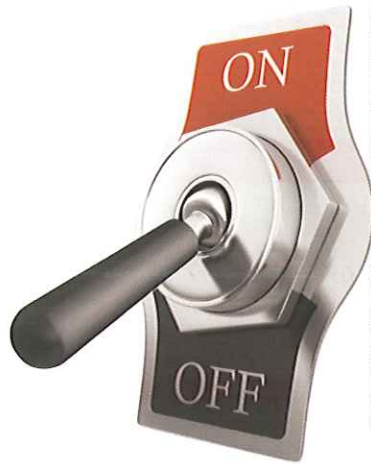
The boiler experienced a runaway firing condition due to the safety shutoff gas valves being stuck. The boiler was also dry due to a malfunctioning low-water fuel shutoff and plugged piping. The resulting intense heat melted all the tubes in the boiler. The boiler had been seriously overheated causing the steam drum to grow lengthwise about eight inches, parting the insulation. This caused the "cherry red glow," a fireman reported.

In the following case study, an old elementary school that had been closed down for several years was being reopened for a new use. The water tube boiler in the building had not been inspected since the shut down and the boiler was then placed into service without following the proper procedures.

If the boiler had been properly serviced and inspected before being placed in service, this incident could have been completely preventable. With the proper inspection, the inspector should have recommended that all controls and safety devices as well as the plugged low-water fuel shut-off piping should be replaced. In addition, the fuel train would have been upgraded to meet the current standards.

Reviewing this incident, the following observations were made:

- The boiler was outfitted with only one low-water fuel shutoff – a combination low-water fuel shutoff and water feeder;
- The piping to the low-water fuel shut-off was plugged.
- Both safety shut-off valves in the main fuel gas train had failed in the open position. These are normally closed valves which must be energized to open, and when examined all power had been shut off.
- One of the safety shutoff gas valves was an obsolete diaphragm, weight-loaded valve, actuated by an electrical solenoid.
